Tortosa H.O.A.  
 8360 E. Via de Ventura  
 Suite 100 Bldg L  
 Scottsdale, AZ 85258

July 18, 2012

**Follow-up report**

### Interim Update

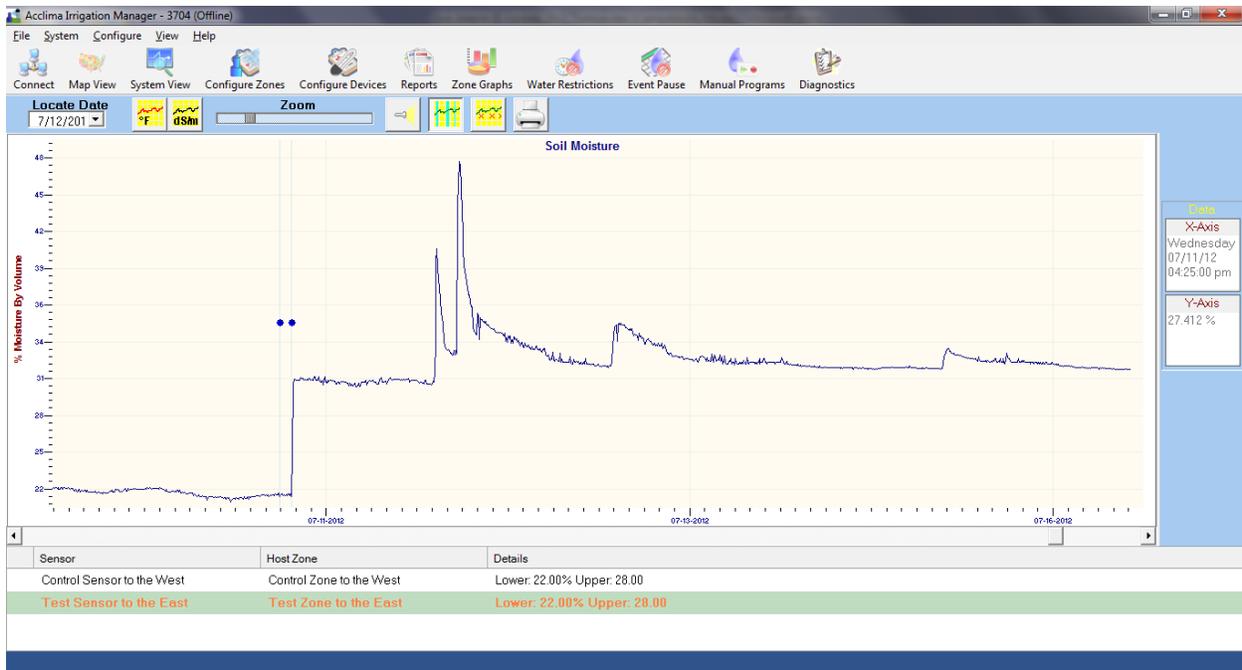
July 10 data and visual observations determined leaching was needed for water to infiltrate the surface and penetrate to the sensor depth on the Treated area. On-site visit July 17, verified leaching had been accomplished by Mother Nature’s rainfall of .4” July 12-14. Sensor data from the Treated side, below, depicts the rain event. Soil moisture ‘spiked’ to well over 40%. The blue dots represent the irrigation event on the evening of July 10. Prior irrigations had not accurately reflected a moisture change. The Acclima system sensor on the Treated side now appears to be soundly working.

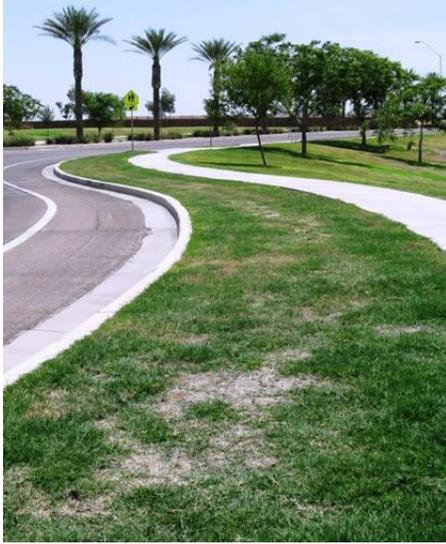
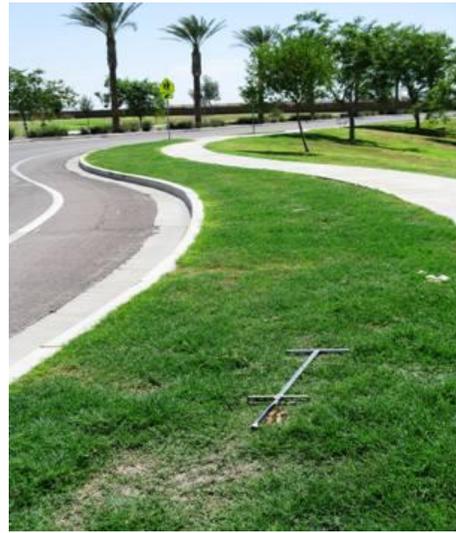
Additional irrigation water to leach high salts needs be added to the Solution equation when working with high EC waters. The photographs below are taken one week apart, before and after the rain event. The Treated side recovered after a natural leaching.

Figure 1-Treated side photo taken on 7-10

photo taken on 7-17

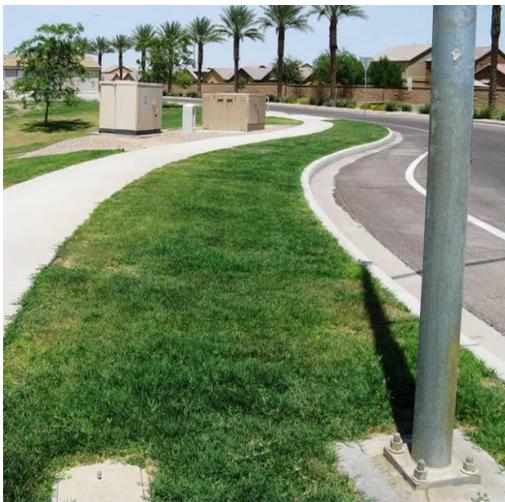
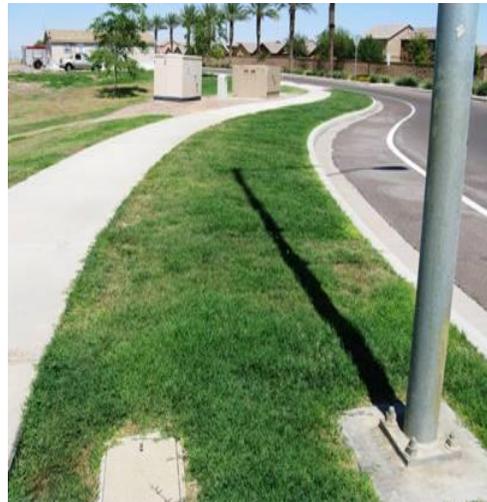
Figure 2- Control side photo taken on 7- 10

photo taken on 7-17

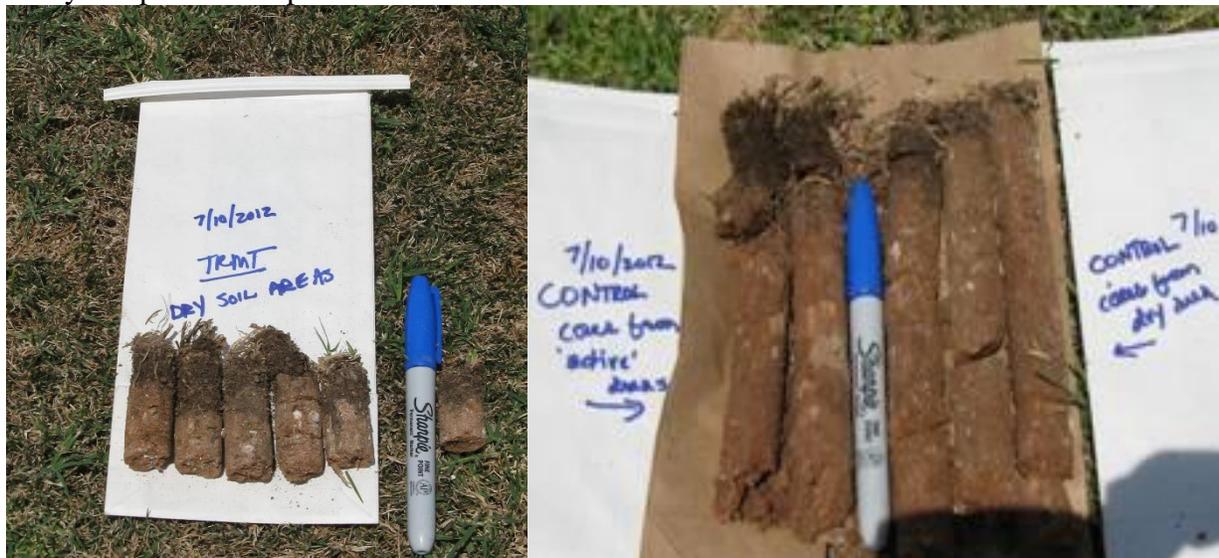
Soil cores were taken on July 10 for analyses. The turf was not healthy enough for the tissue to be properly sampled. Across the Treated area, a hardpan was encountered at 3-3 1/2". A hardpan is a layer within the soil profile that impedes water penetration. The Control side was easily sampled to a depth of 6-7".

Hardpans can develop through physical means such as compaction from equipment or spreading soil of a different texture on top of existing or in-situ soil. Hardpans also are created by chemical processes, an example being an accumulation of salt from irrigation water forming below the surface. Often pans are a combination of both physical and chemical processes. The irrigation water at Tortosa is high in salt. Four Peaks consistently applies products (Absolute & sulfuric acid injected the water) to combat salt build up. However, by programming the Acclima system to irrigate ‘on-demand’, only enough water to meet the turf’s requirement is applied. An additional fraction of water is needed to leach or move salt below the root zone.

The Trial area, both Treated and Control, should be ‘leached’. This will basically involve manually irrigating the Trial area for 60 minutes. Moisture sensor data will be reviewed shortly after leaching and soil cores pulled to visually inspect depth of water penetration.

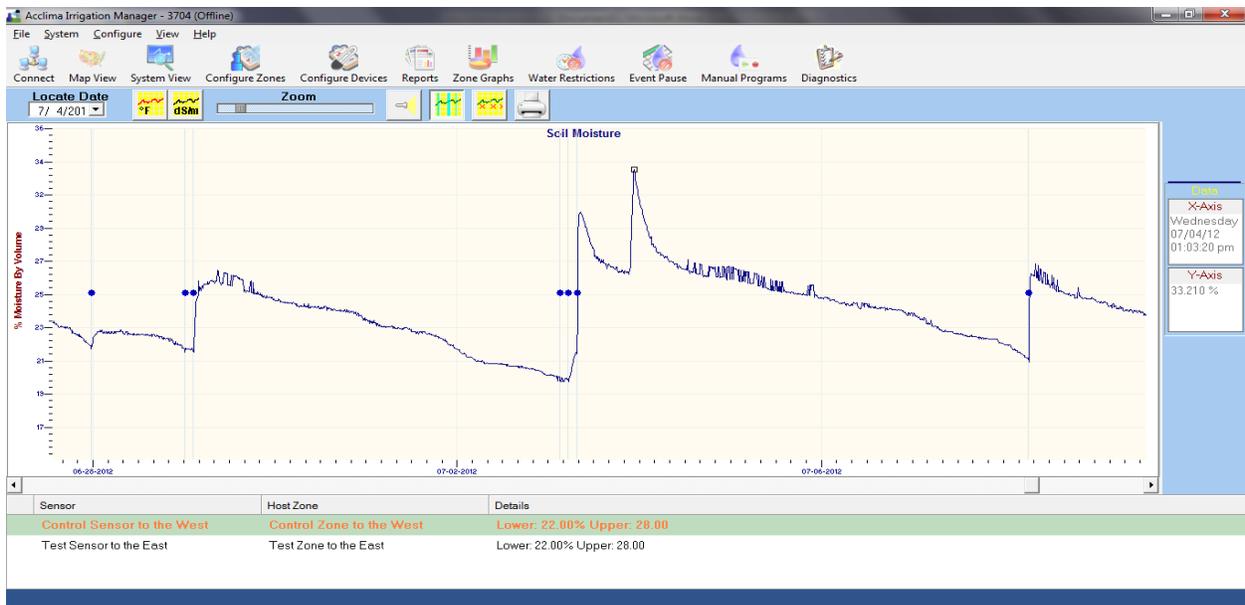
The percent soil moisture in the top 3” soil cores of the Control side was 13.5%; the Treated side held 9.7% moisture. The difference in soil moisture in the top 3” can be attributed to reduced irrigation of the Treated side. However, an abnormality in the data recorded by the sensors on July 4 signals an alert that needs further examination. Maricopa received ~.25” of rain on July 4. The Control moisture sensor (remember, sensors are placed at 4” depth) recorded this event. The soil moisture graph increased from 26.5% at noon to 33.2% at 1:00 pm. A clip shot of the graph below shows the double spike in moisture on July fourth with the second peak due to the rain. The blue dots depict irrigation events with each blue dot representing a 10 minute watering interval.

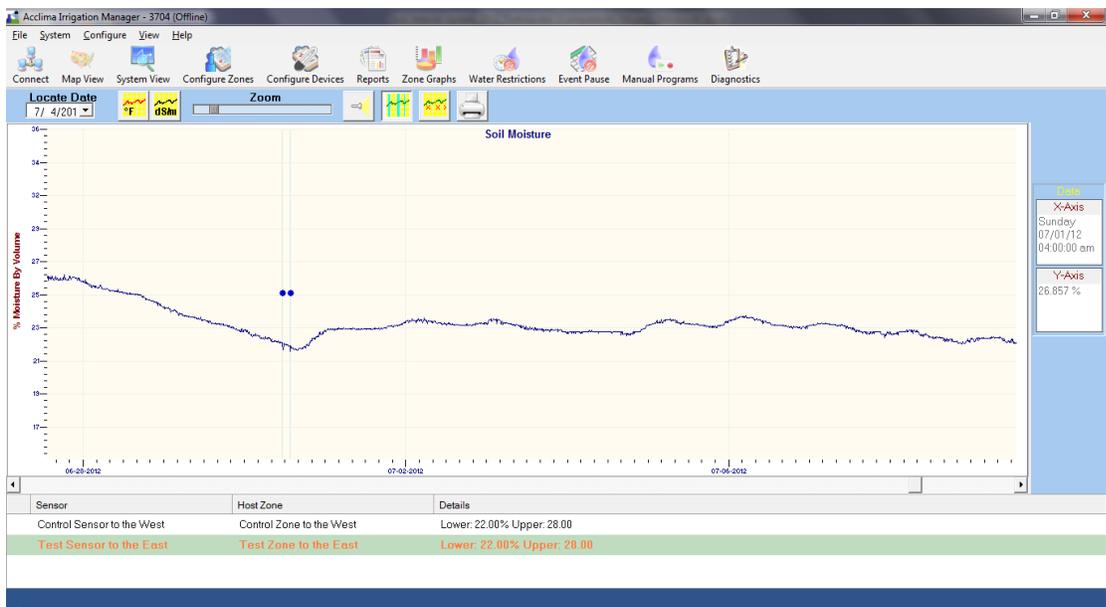
Below is the graph of the Treatment side during the same time frame. The rain event on July 4th is barely visible with soil moisture rising only .5%. The 2 blue dots representing 20 minutes of irrigation on July 1 increased soil moisture above the 22% lower threshold, but is not seen as a normal ‘spike’ in moisture.

The above suggests a) water infiltration on the Treatment side is impeded relative to the Control side, or b) the sensor on the Treatment side is not recording soil moisture accurately. Note: Water infiltration problems can be seen on other turf sections surrounding the test plot, especially on sloped areas.
